Assessment of Dam Safety Coal Combustion Surface Impoundments (Task 3) Final Report

American Electric Power

Conesville
Generating Station

February 15, 2010

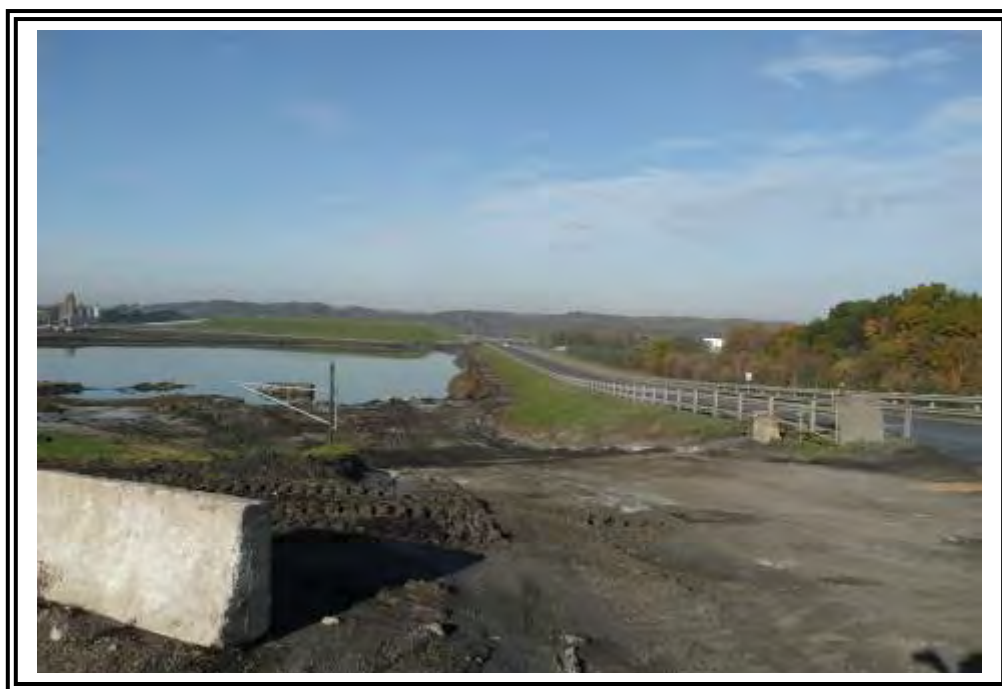
1

Looking west across the north corner of the Fly Ash Pond along upstream slope of North Haul Road Dike.
The plant and closed FGD area are in the background.

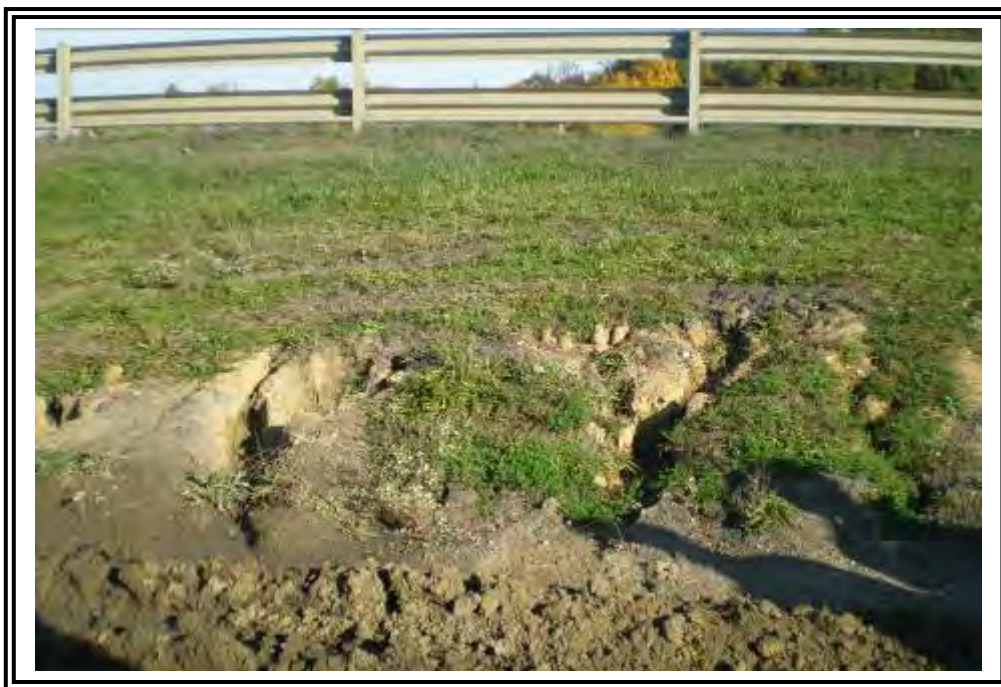
3

Erosion rills from haul road run off on the upstream slope of the North Haul Road Dike.

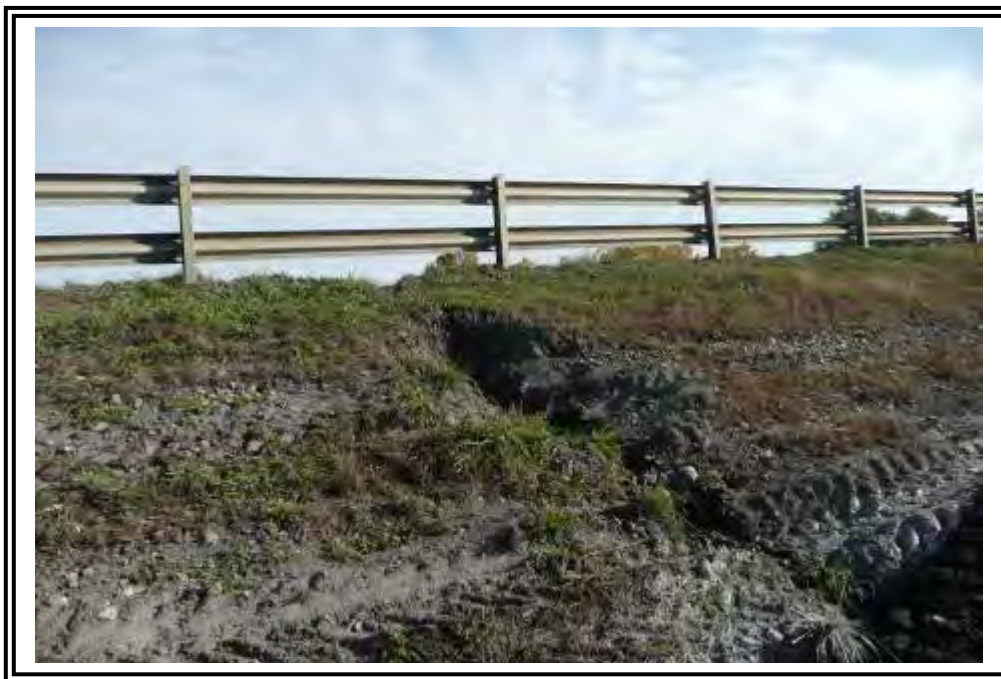
4

Large erosion rill and rutting on the upstream slope of the North Haul Road Dike.

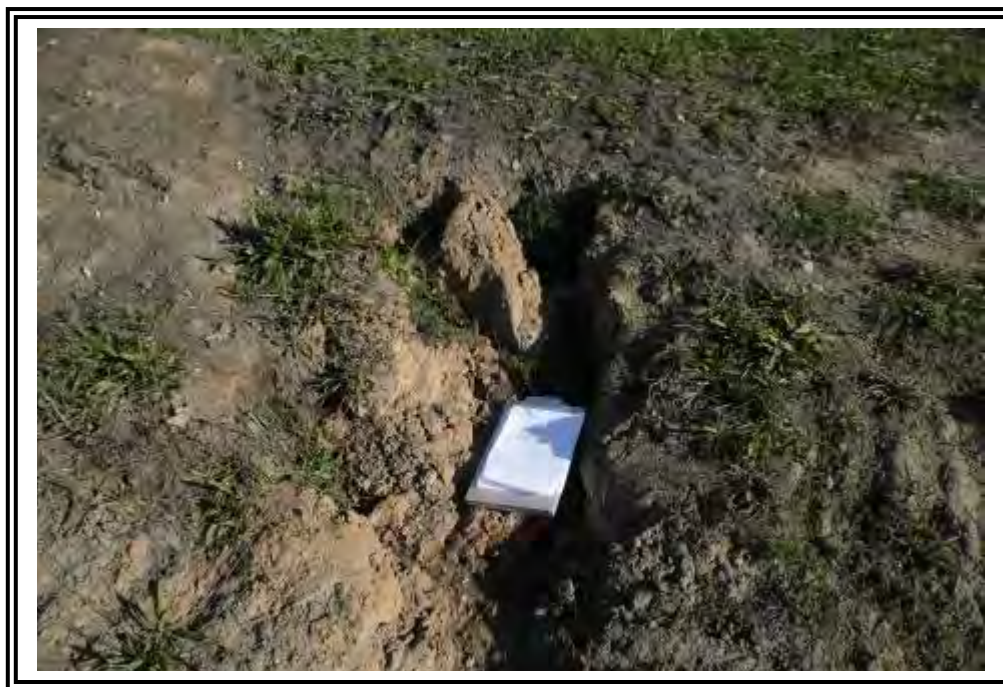
5

A close up of a large erosion rill and loss of vegetation on the upstream slope of the North Haul Road Dike.

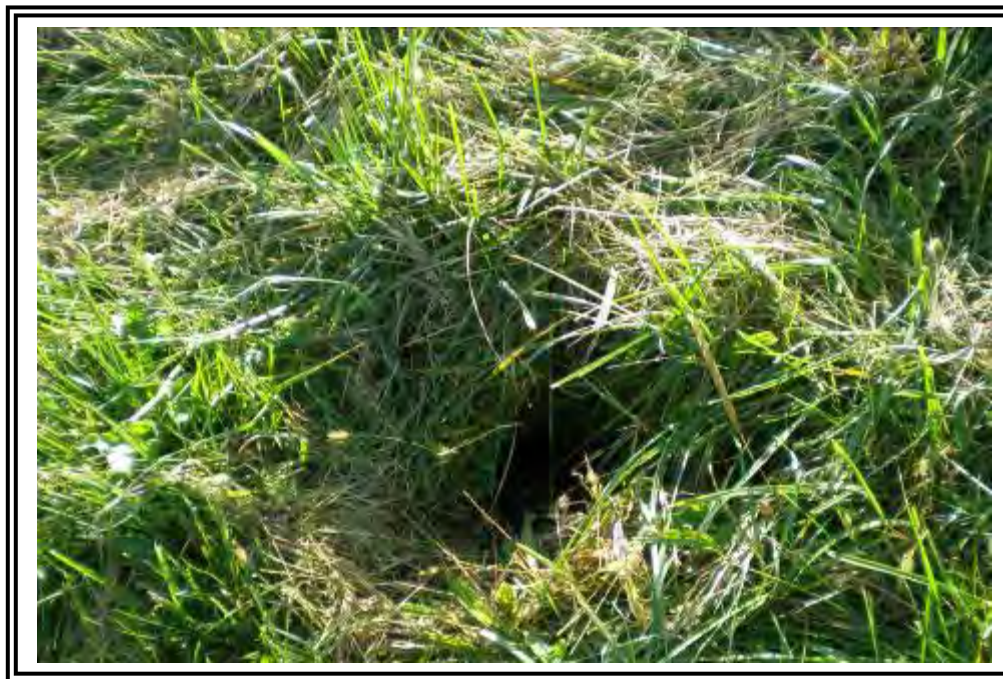
10

Close up of an isolated rodent hole in the downstream slope of the North Haul Road Dike.

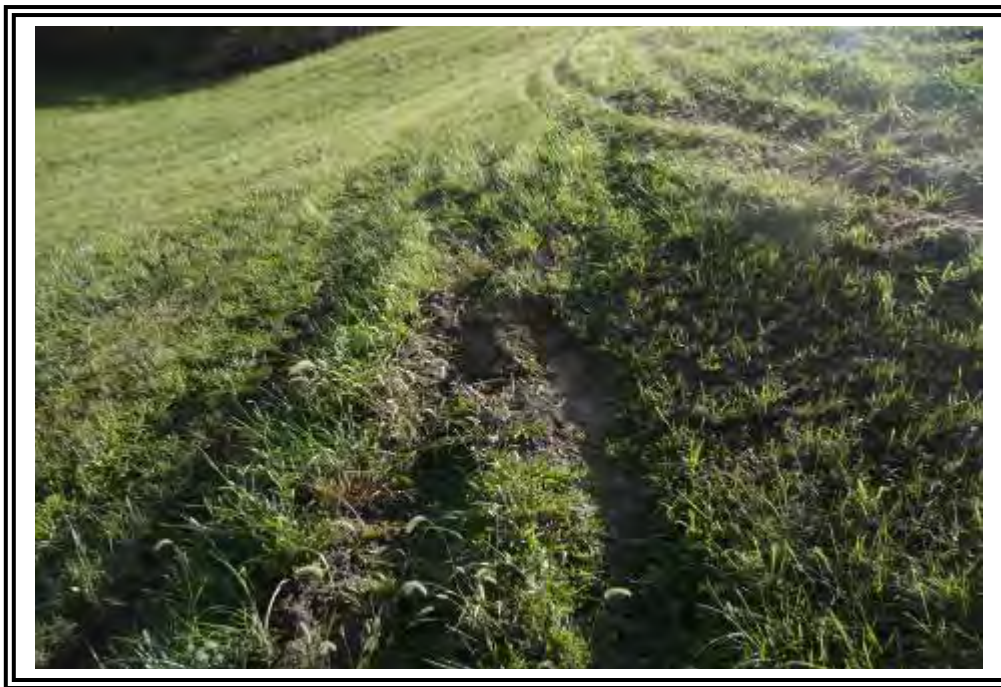
11

Close up of rutting and loss of vegetation on the downstream slope of the North Haul Road Dike.

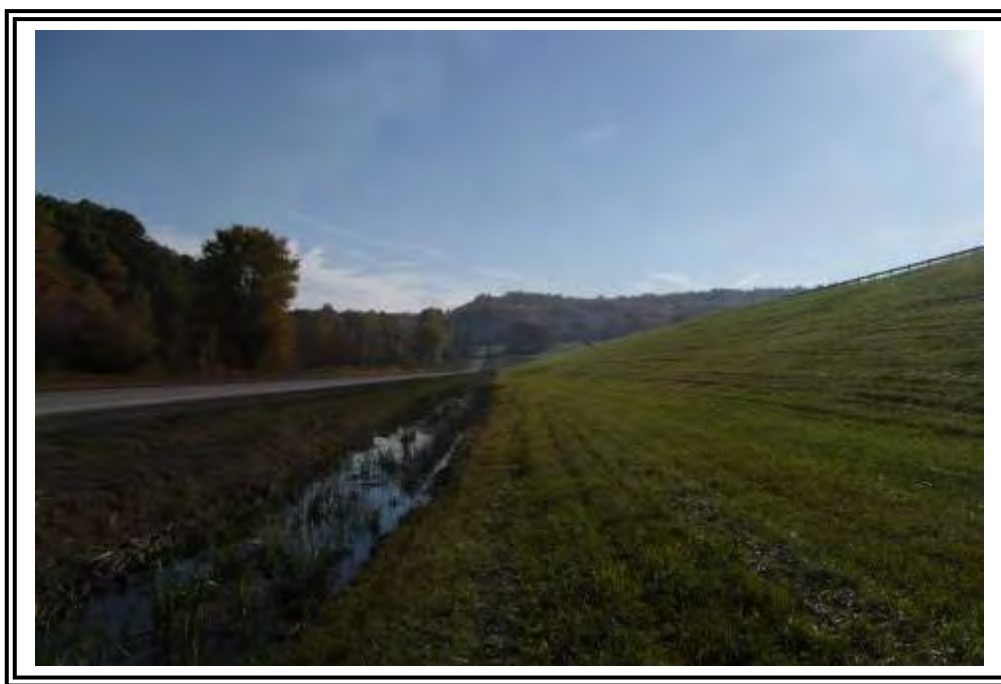
12

Toe of the North Haul Road Dike, looking east.
Standing water in the road ditch along toe can be seen in left of photo.

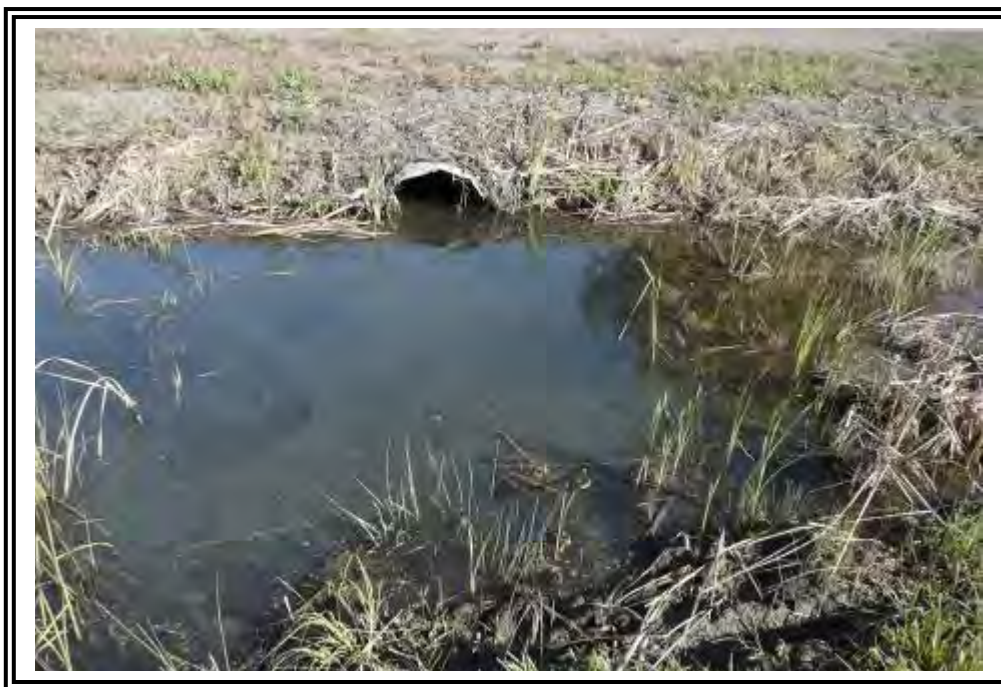
13

Close up of the half submerged drainage pipe under the county road.

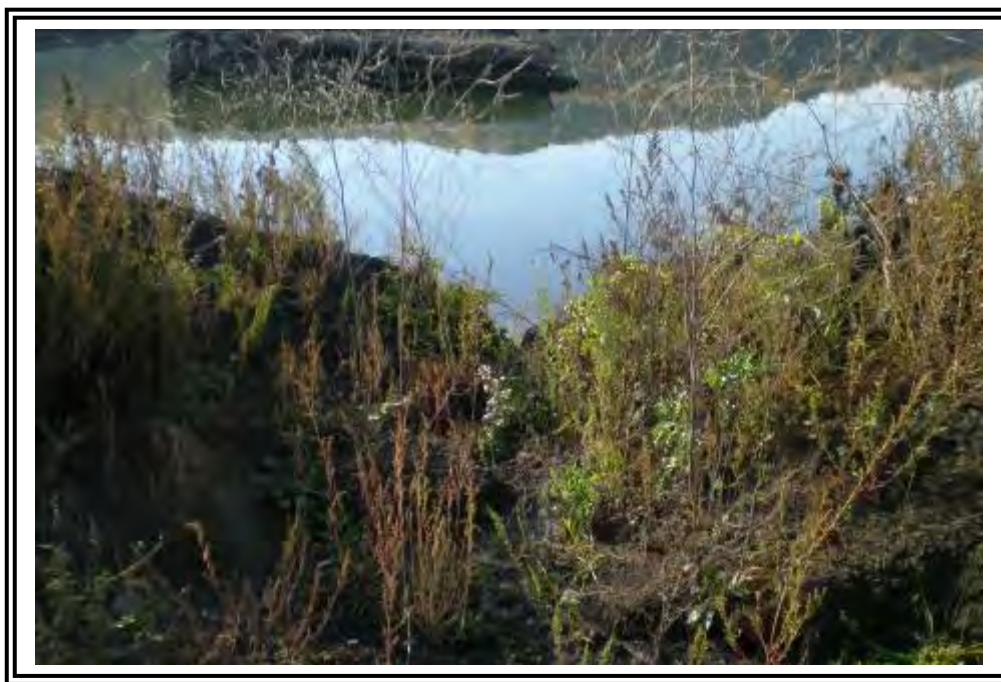
14

Vegetation and erosion rill at edge of Fly Ash Pond and construction road adjacent to the North Haul Road Dike.

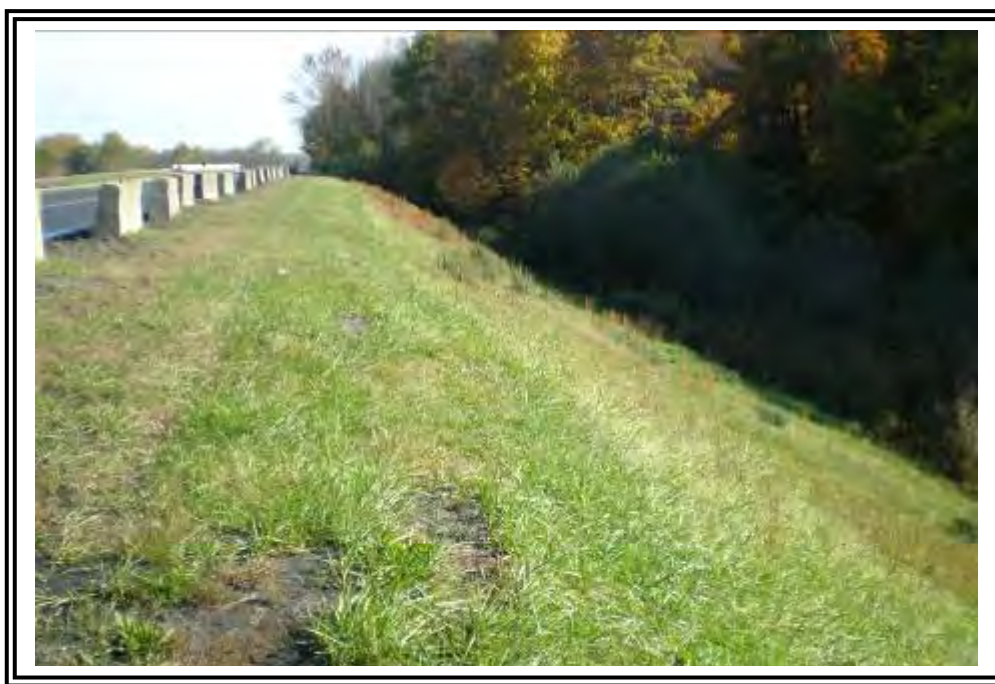
20

Looking northeast along downstream slope of the Coal Haul Road Dike. Small trees and moderate vegetation lower on the slope can be seen in the shade in the right of the photo.

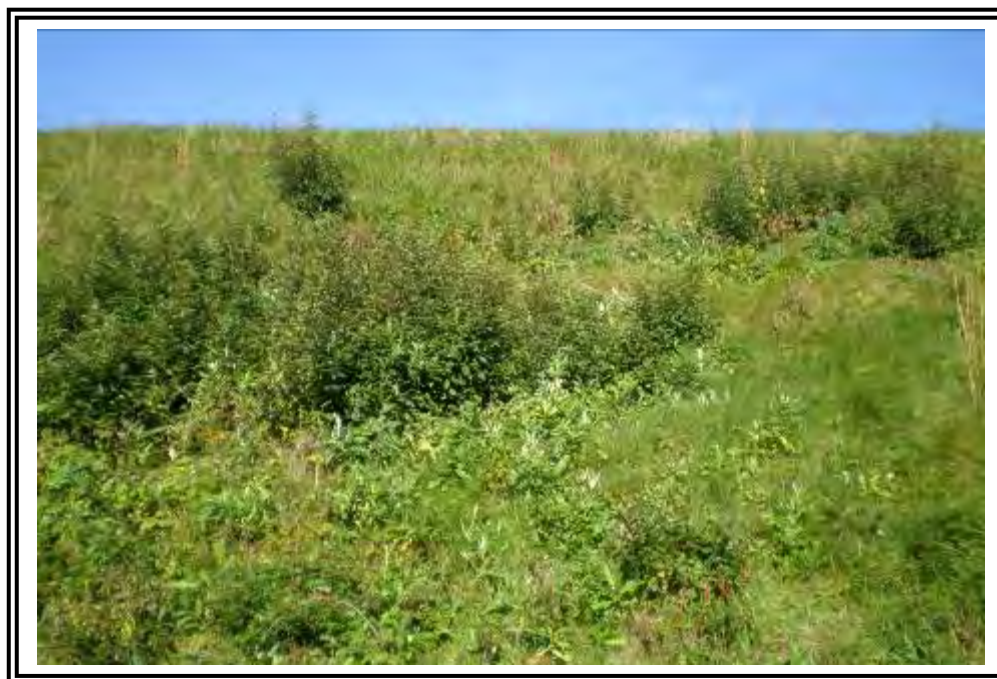
22

Close up of the moderate vegetation on the downstream slope of the Coal Haul Road Dike.

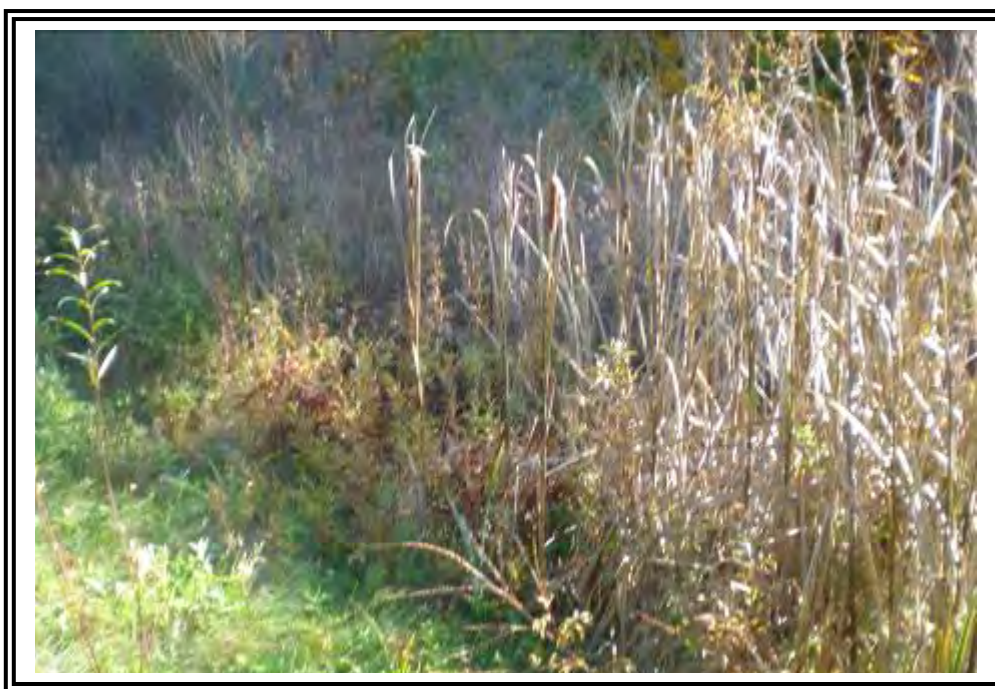
23

Heavy vegetation near the toe of the Coal Haul Road Dike.

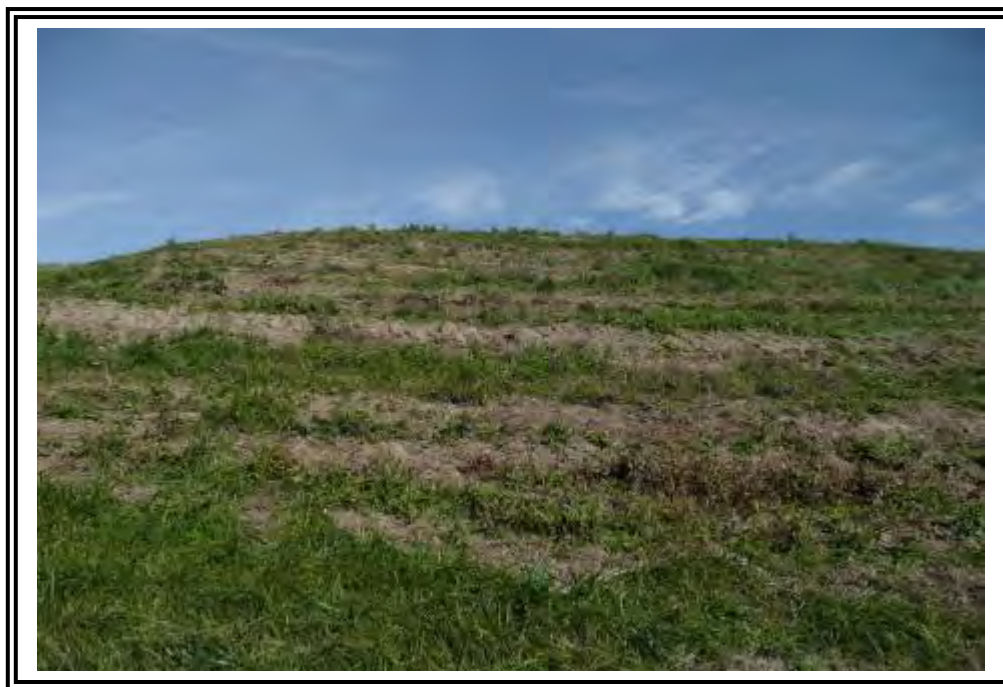
29

Photo Nos. 24 and 28 shows that the downstream slope of the Secondary Dike adjacent to the Clearwater Pond was uniformly graded with appropriate grass cover. Photo No. 27 shows the upstream slope of the Secondary Dike adjacent to the Clearwater Pond. Isolated rutting and loss of the grass cover from mowing operations, as seen in Photo No. 29, was observed during the inspection.

Close up of rutting and loss of grass vegetation on downstream slope due to mowing operations.

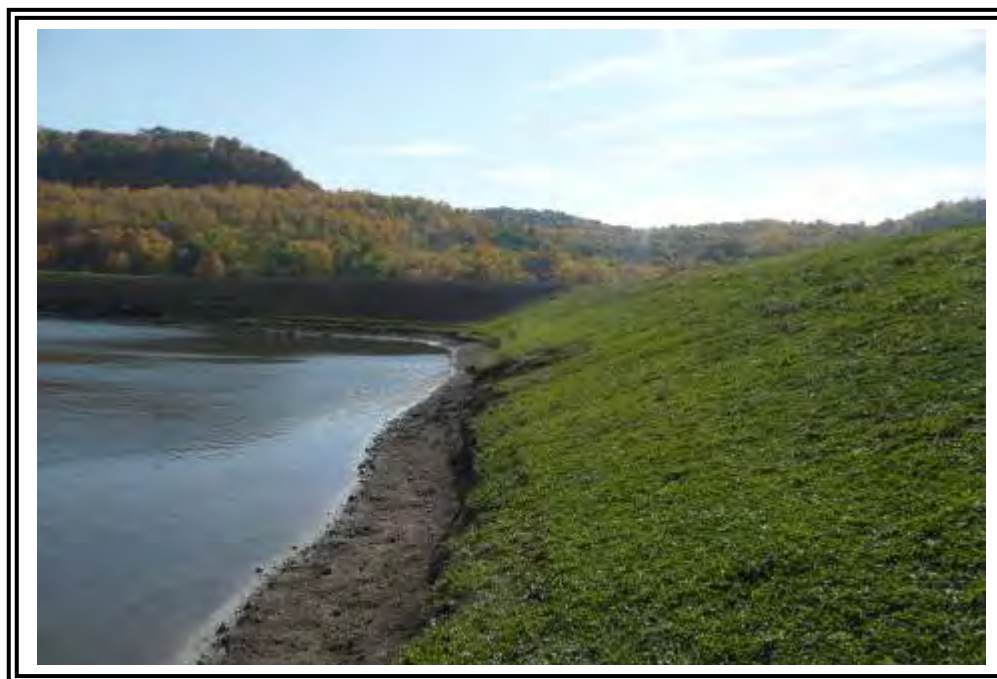
36

Upstream slope at the Clearwater Pond. Notice the beaching along the water line of the slope.

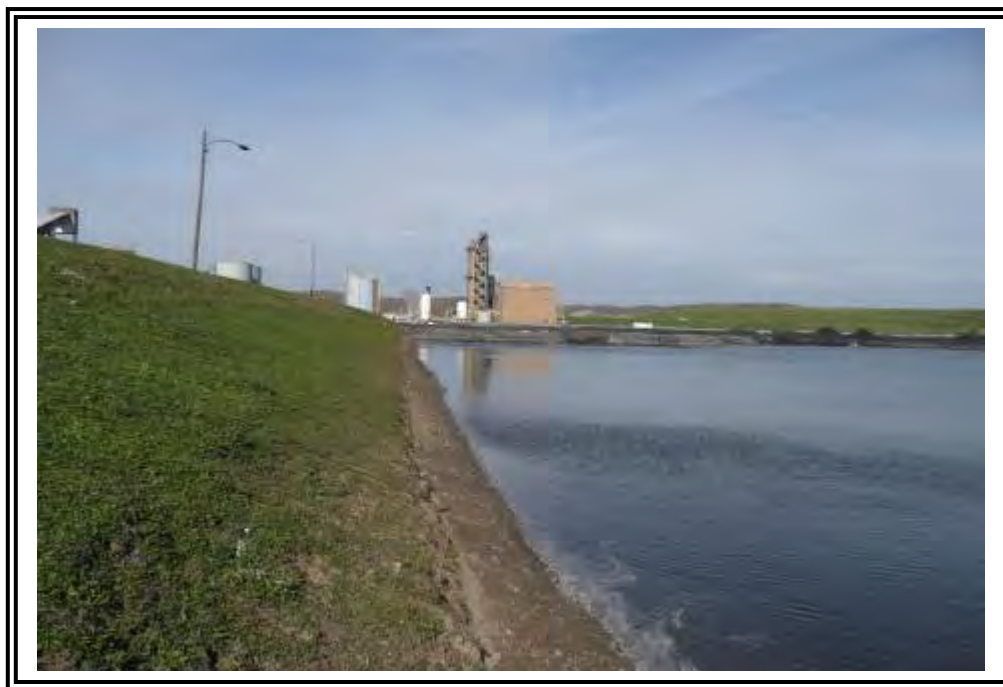
37

Looking northwest along upstream slope of the Southwest Dike along the Bottom Ash Pond.
Notice beaching erosion along the waterline.

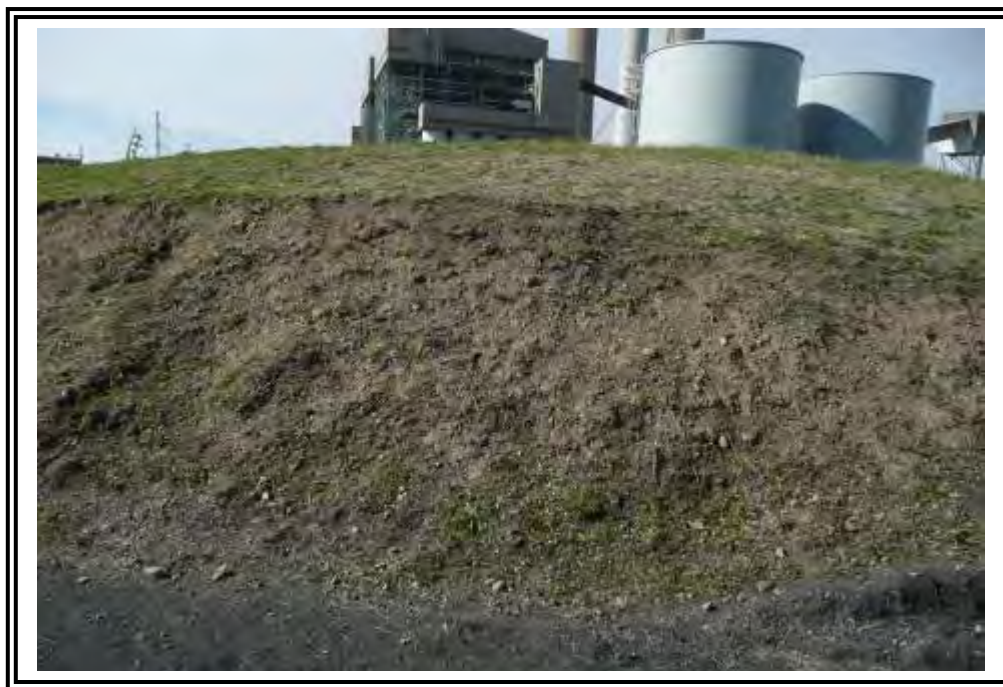
aerial survey, this would leave about 3 to 5 feet of effective freeboard above the water level at the edge of the bottom ash delta surface. Photo Nos. 39 and 59 show this ramp excavation through the dike. In general, the alignment of the Southwest Dike crest does not show signs of change in its horizontal alignment. No evidence of prior releases, failures or patchwork was observed at the time of the site visit. Photo No. 31 shows the dike crest alignment.

Close up of maintenance road cut in Southwest Dike near the plant's water treatment facility.

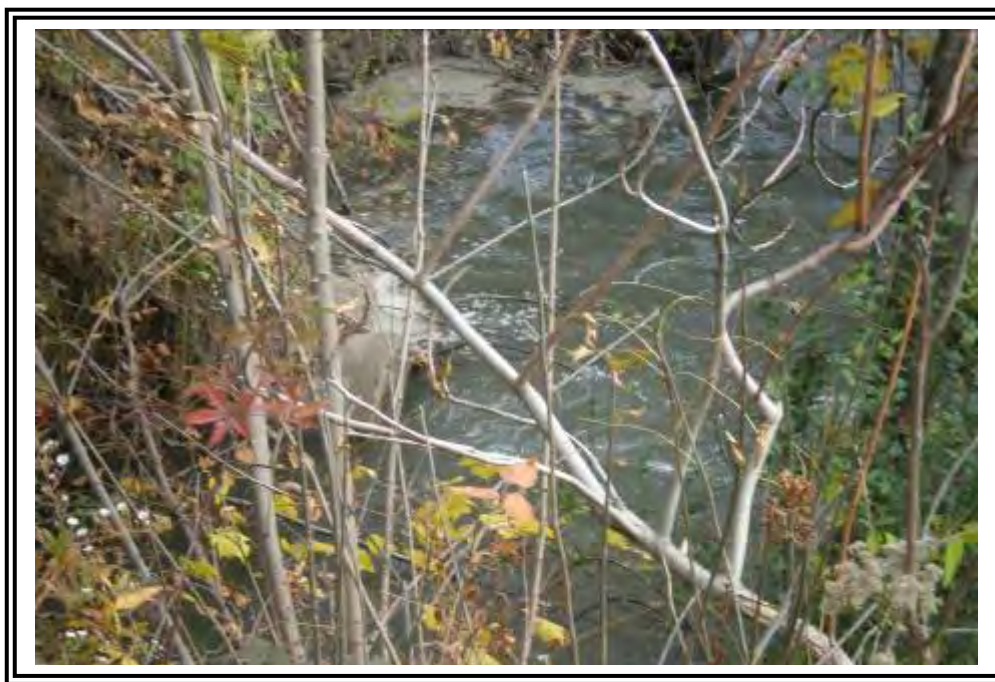
44

Outfall from Clearwater Pond into nearby creek. Heavy vegetation in this area

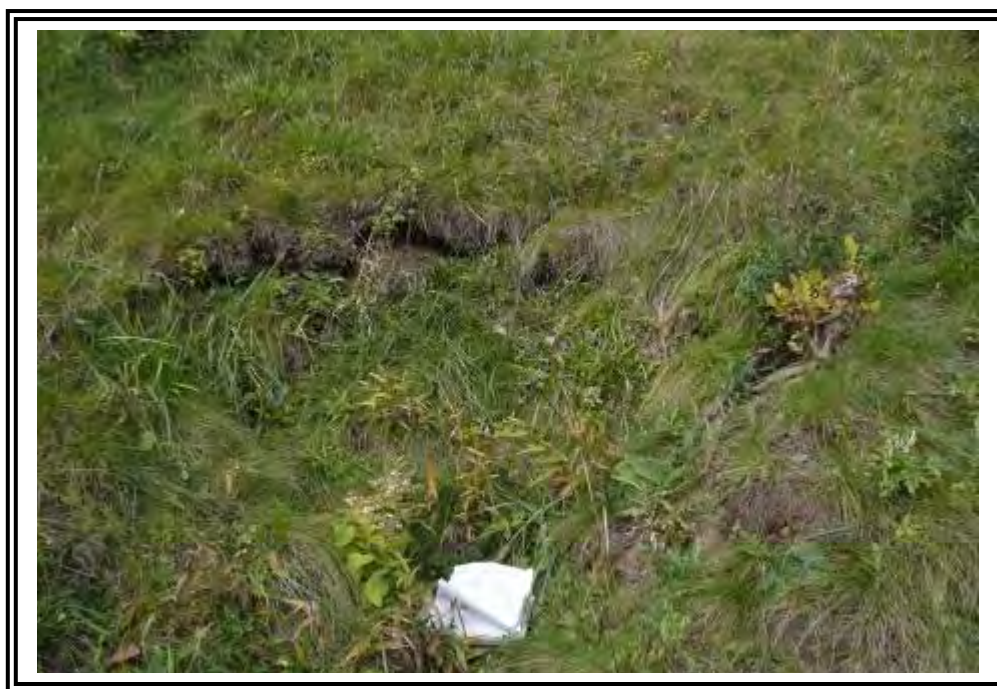
47

Slough in downstream slope of Coal Haul Road Dike.

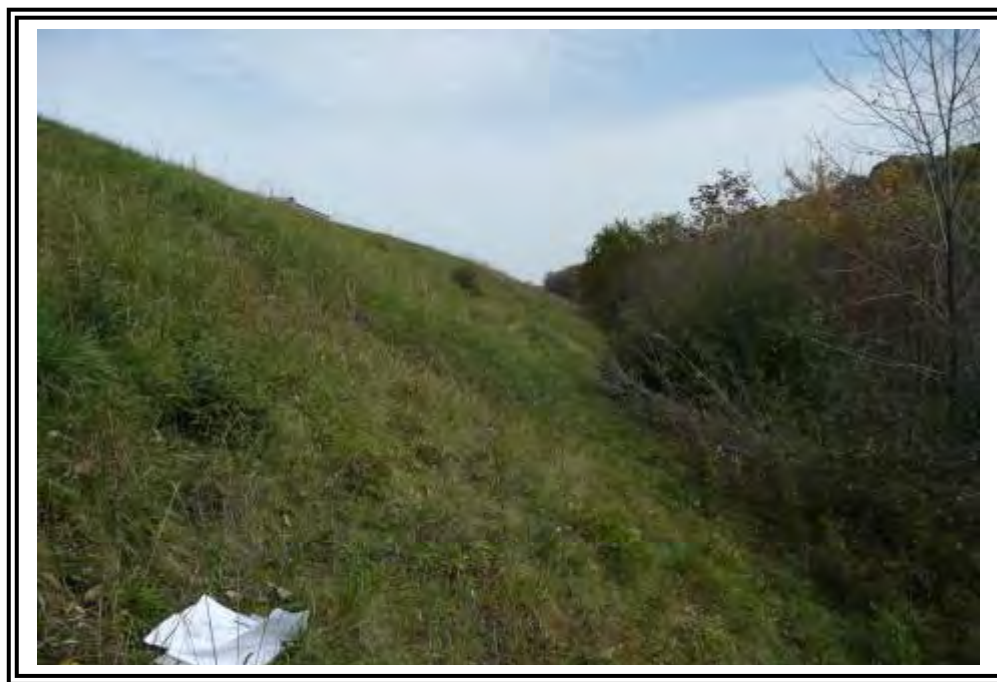
48

Another view of the slough in Coal Haul Road Dike, looking northeast.

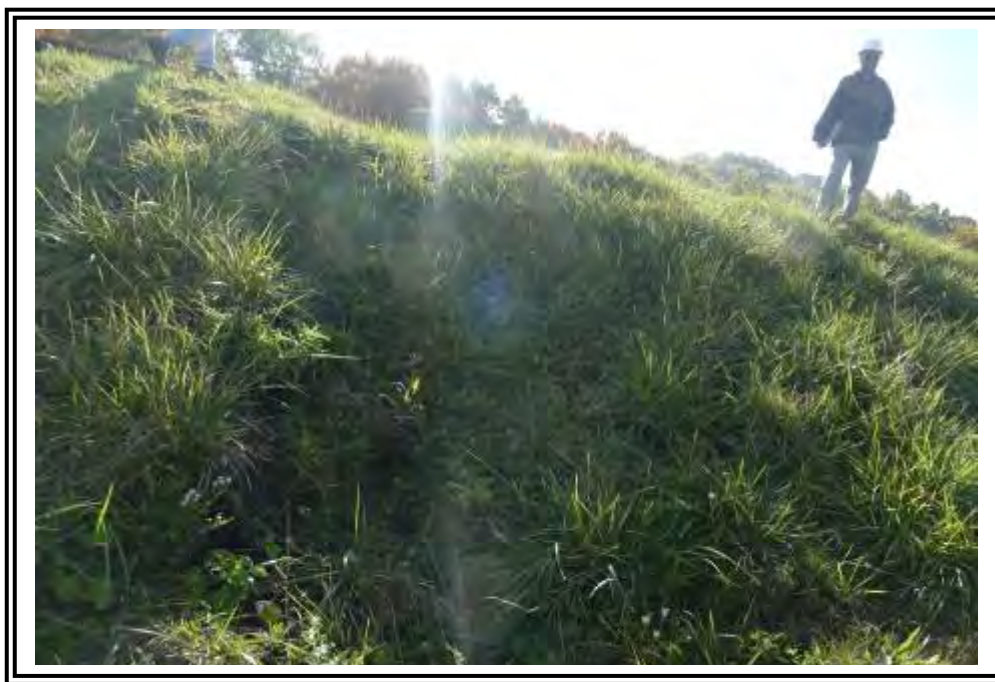
50

Grassed older erosion rill in upstream slope of Coal Haul Road Dike.

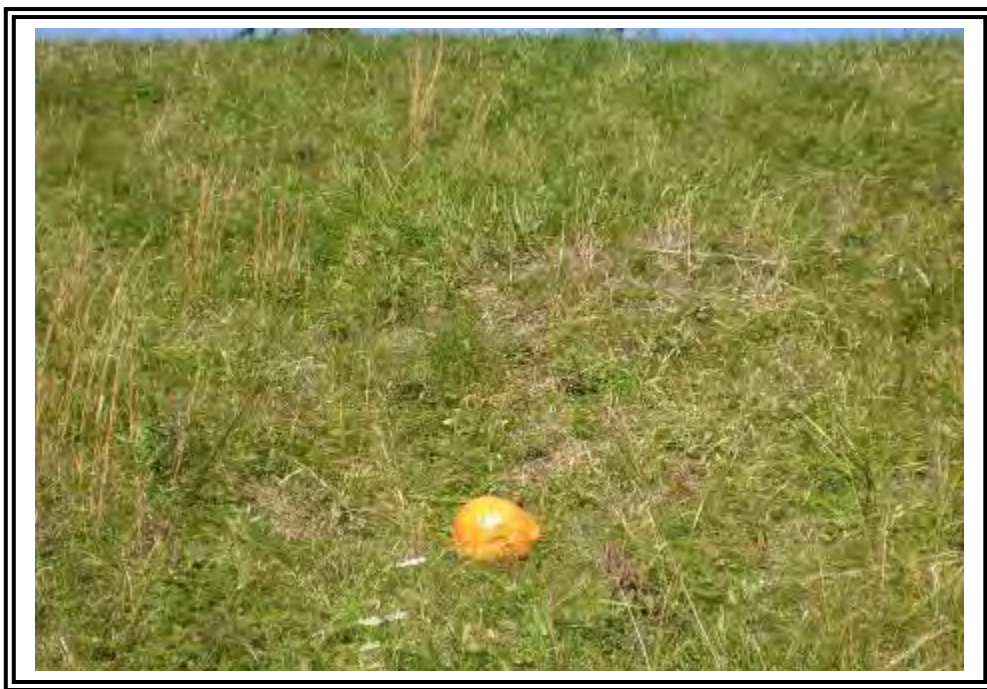
51

Grassed erosion rill on downstream slope of Coal Haul Road Dike. Hard hat is in bottom of rill.

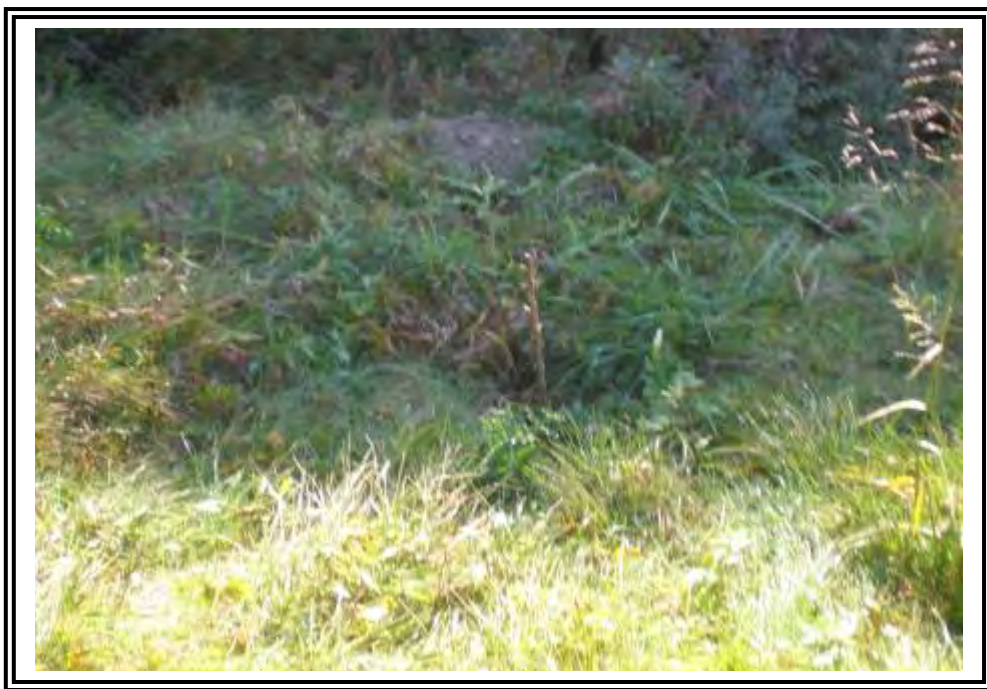
53

Open rodent burrow in area of older collapsed burrows that have become erosion rills (stick is in burrow) in Coal Haul Road Dike.

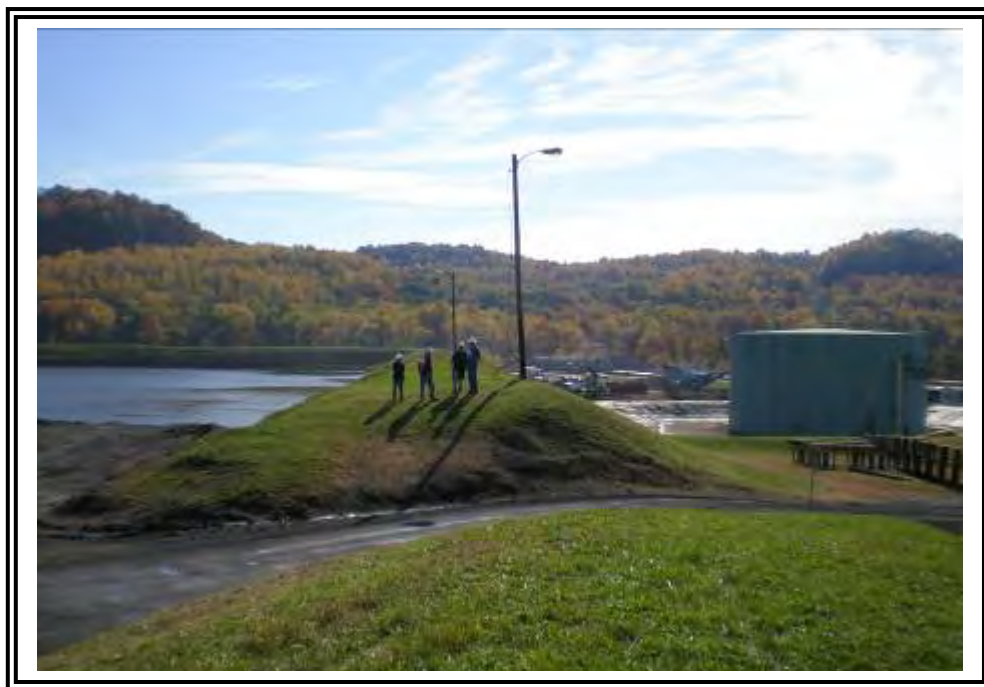
59

Maintenance road cut in Southwest Dike near the plant's water treatment facility, looking southeast.

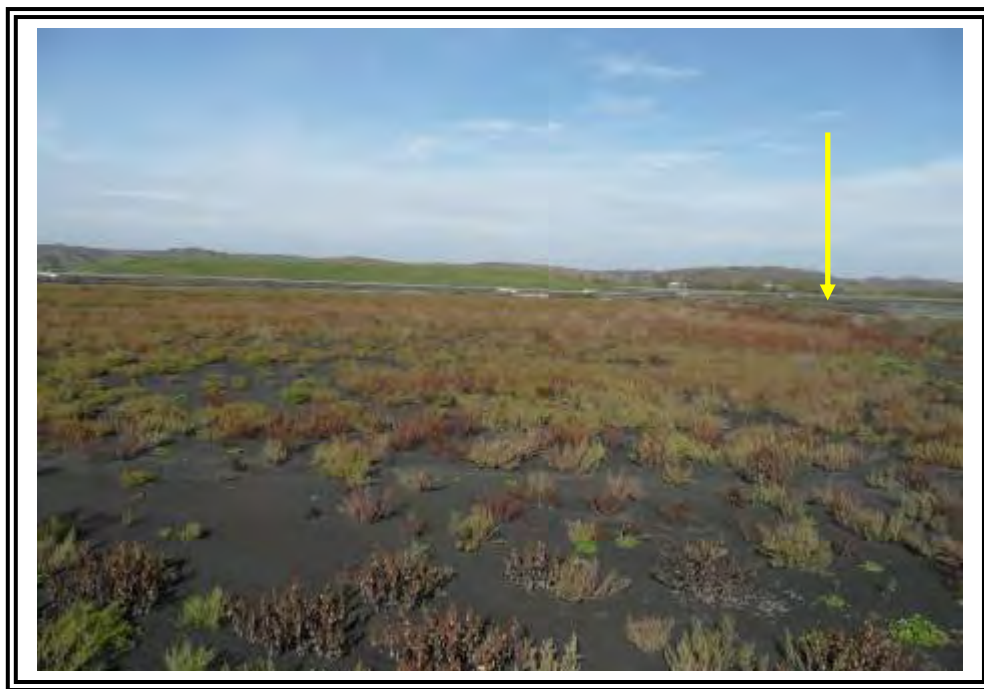
61

The crest of the splitter dikes appeared reasonably uniform as shown in Photo Nos. 25 and 32. Most of these splitter dikes were generally void of vegetation where activity in the pond area is ongoing or has been fairly recent. Less active areas, as noted in Photo No. 61, begin to support

Central Fly Ash Pond area and vegetated interior divider dike between the Fly Ash Storage area and Central Fly Ash Pond area (see arrow on right side of photo).

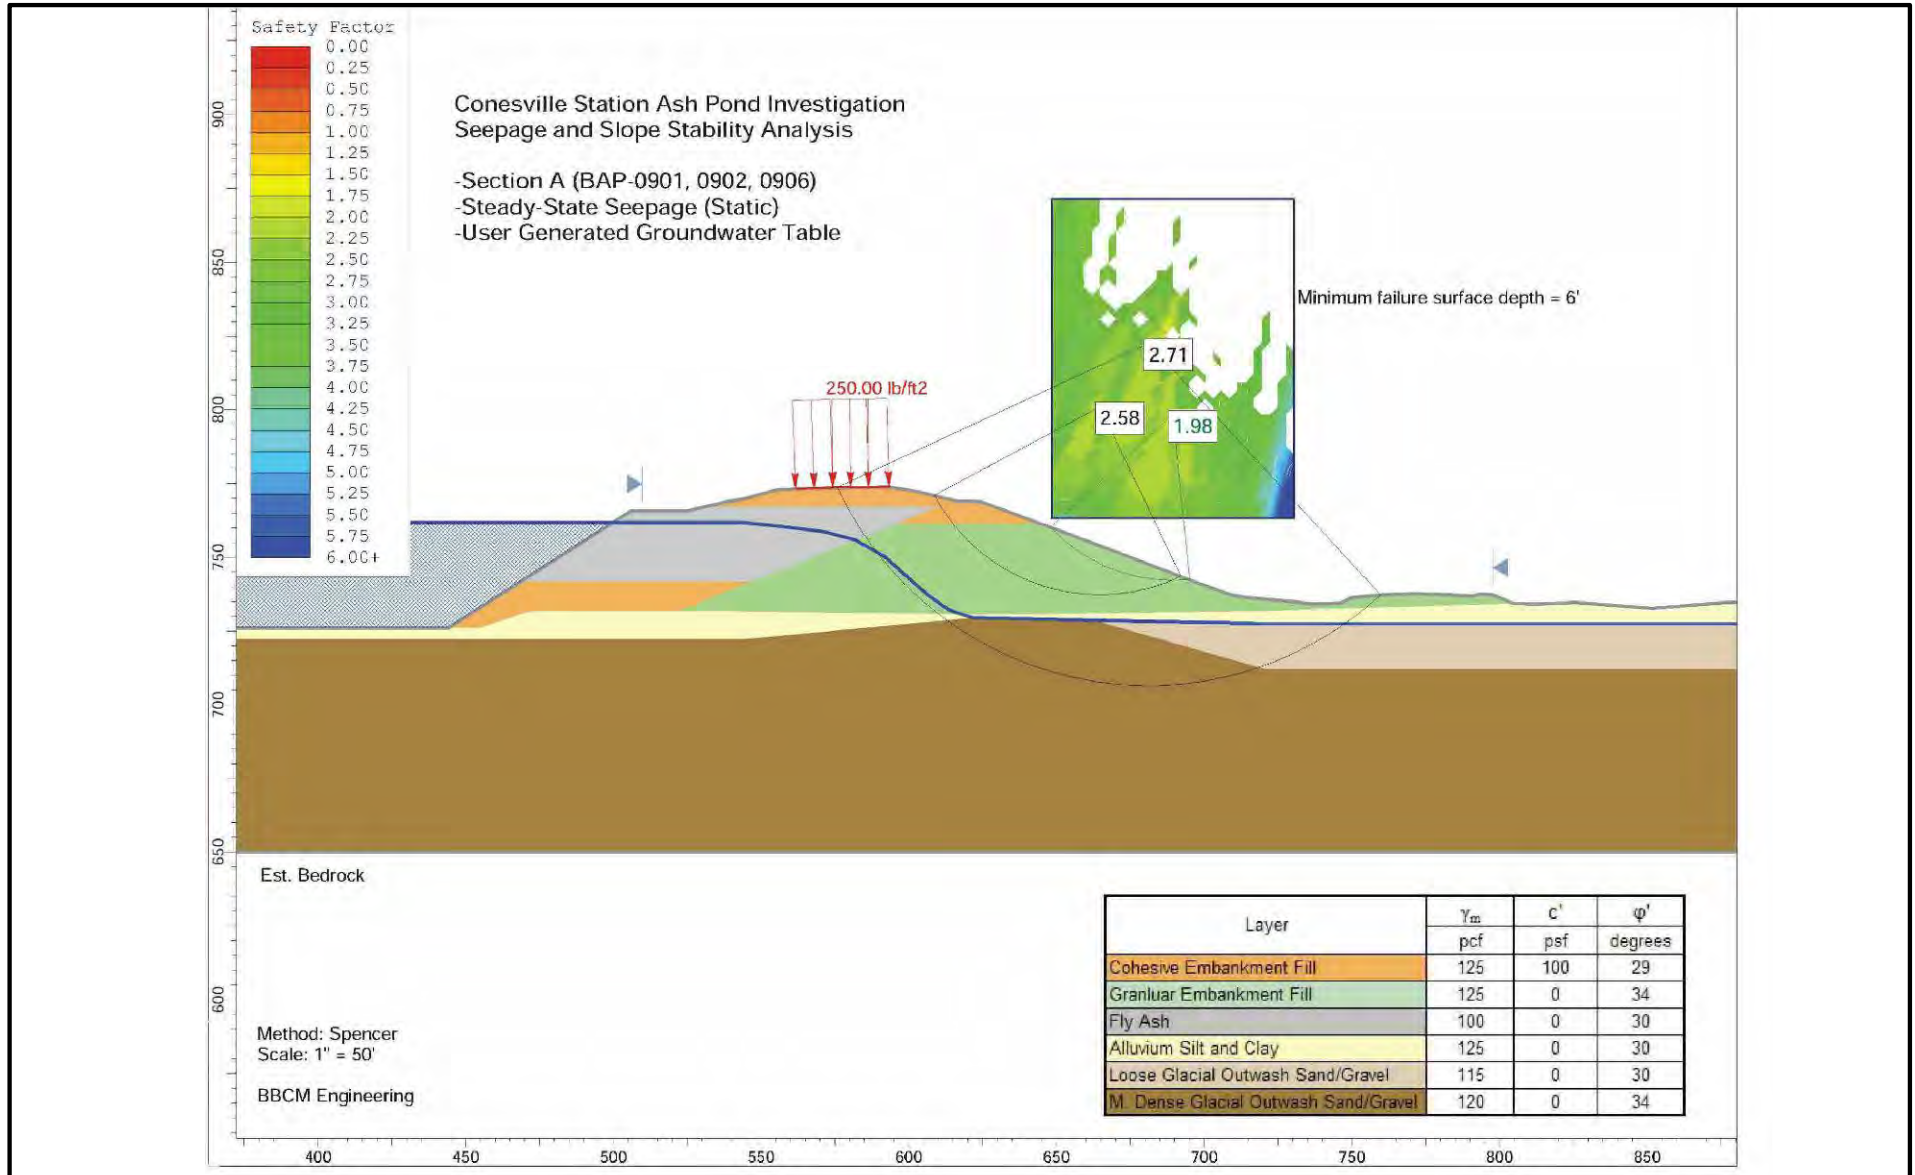
FIGURE 8B

- The downstream slope stability outputs for the steady state load condition for Cross Section B show failure planes within the embankment soils. If the alluvium silt/clay was modeled with a soft layer at the depth corresponding to the low sample effort, a more critical failure plane may actually fall within the alluvium foundation soils and not the embankment soils.

Section 4.7 outlines our recommendations for tasks that should be performed to confirm that the embankments are stable under the loading conditions discussed above.
